Train Derailment – Slidell, LA.

Amtrak Passenger Train

April 20th, 2011

Train Derailment

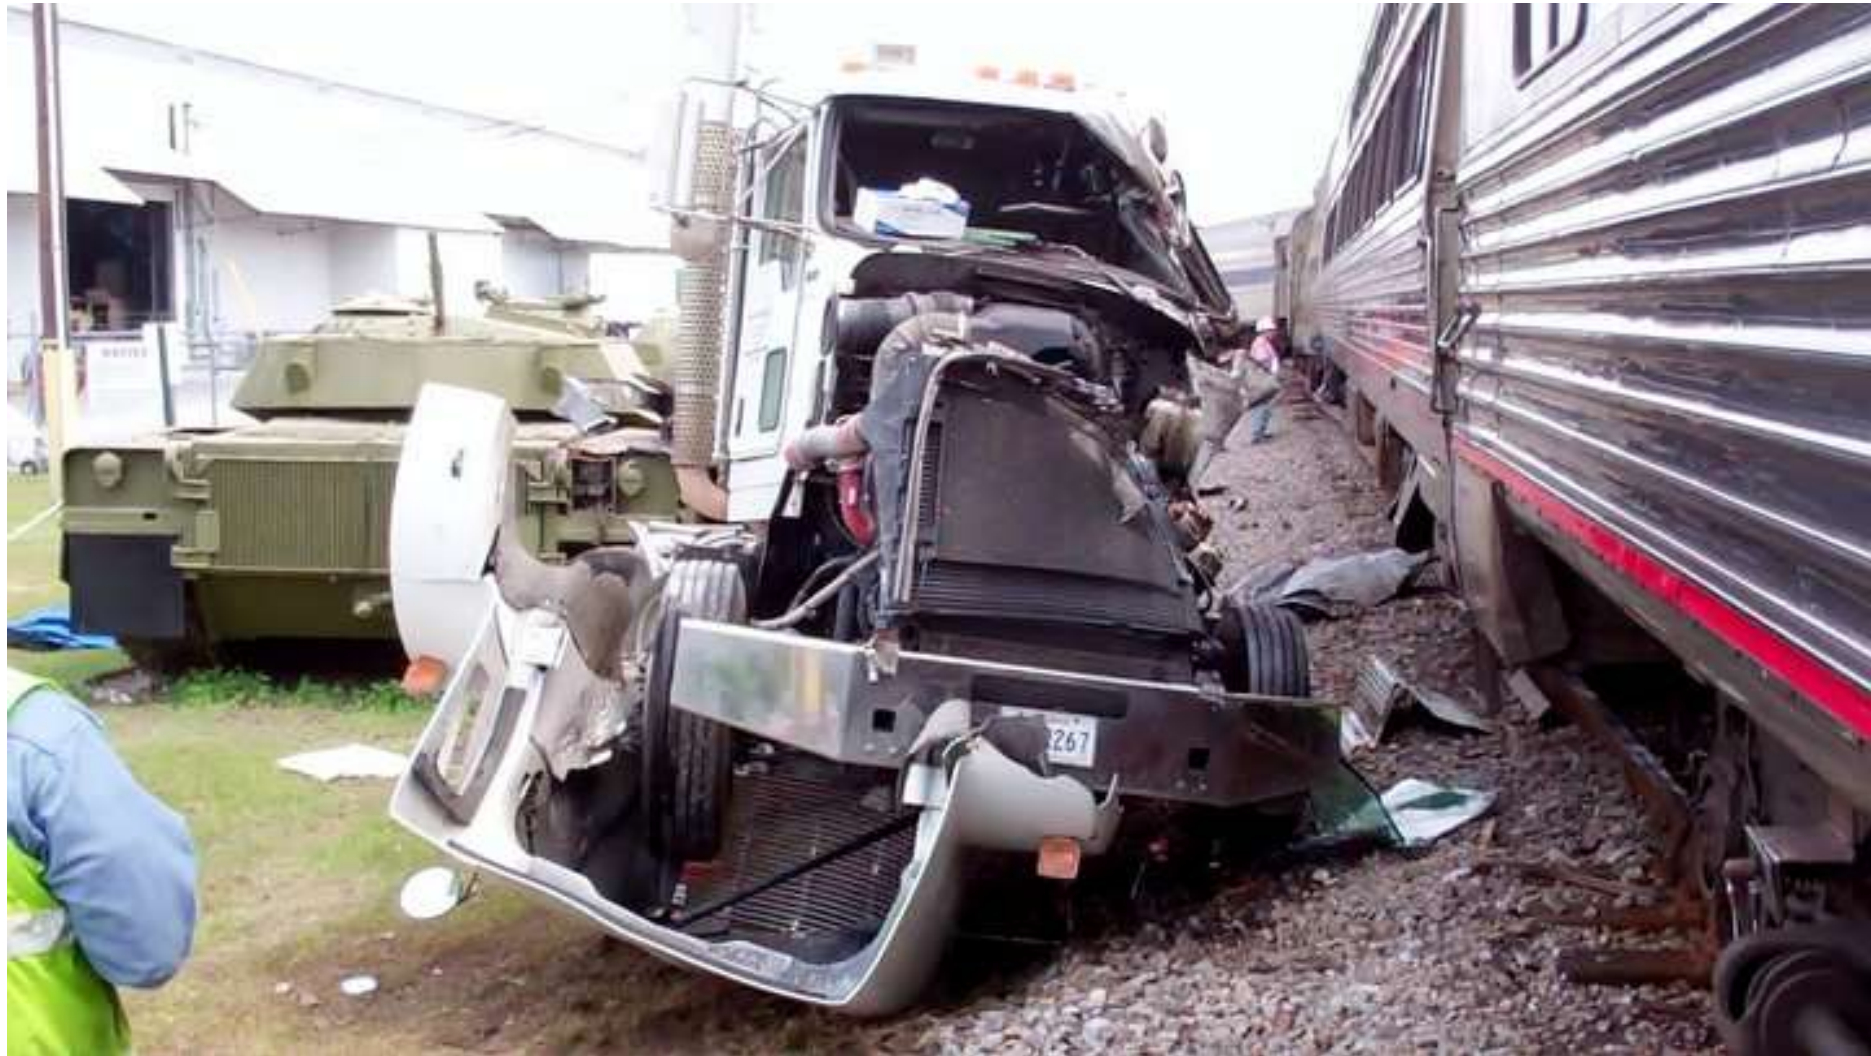
18 Wheeler Tractor Trailer

- Engine 13 and AASI personnel removed the driver from the truck. He was transported to SMH with moderate injuries.
- Engine 13 secured a small fuel leak from the saddle tank of the truck.

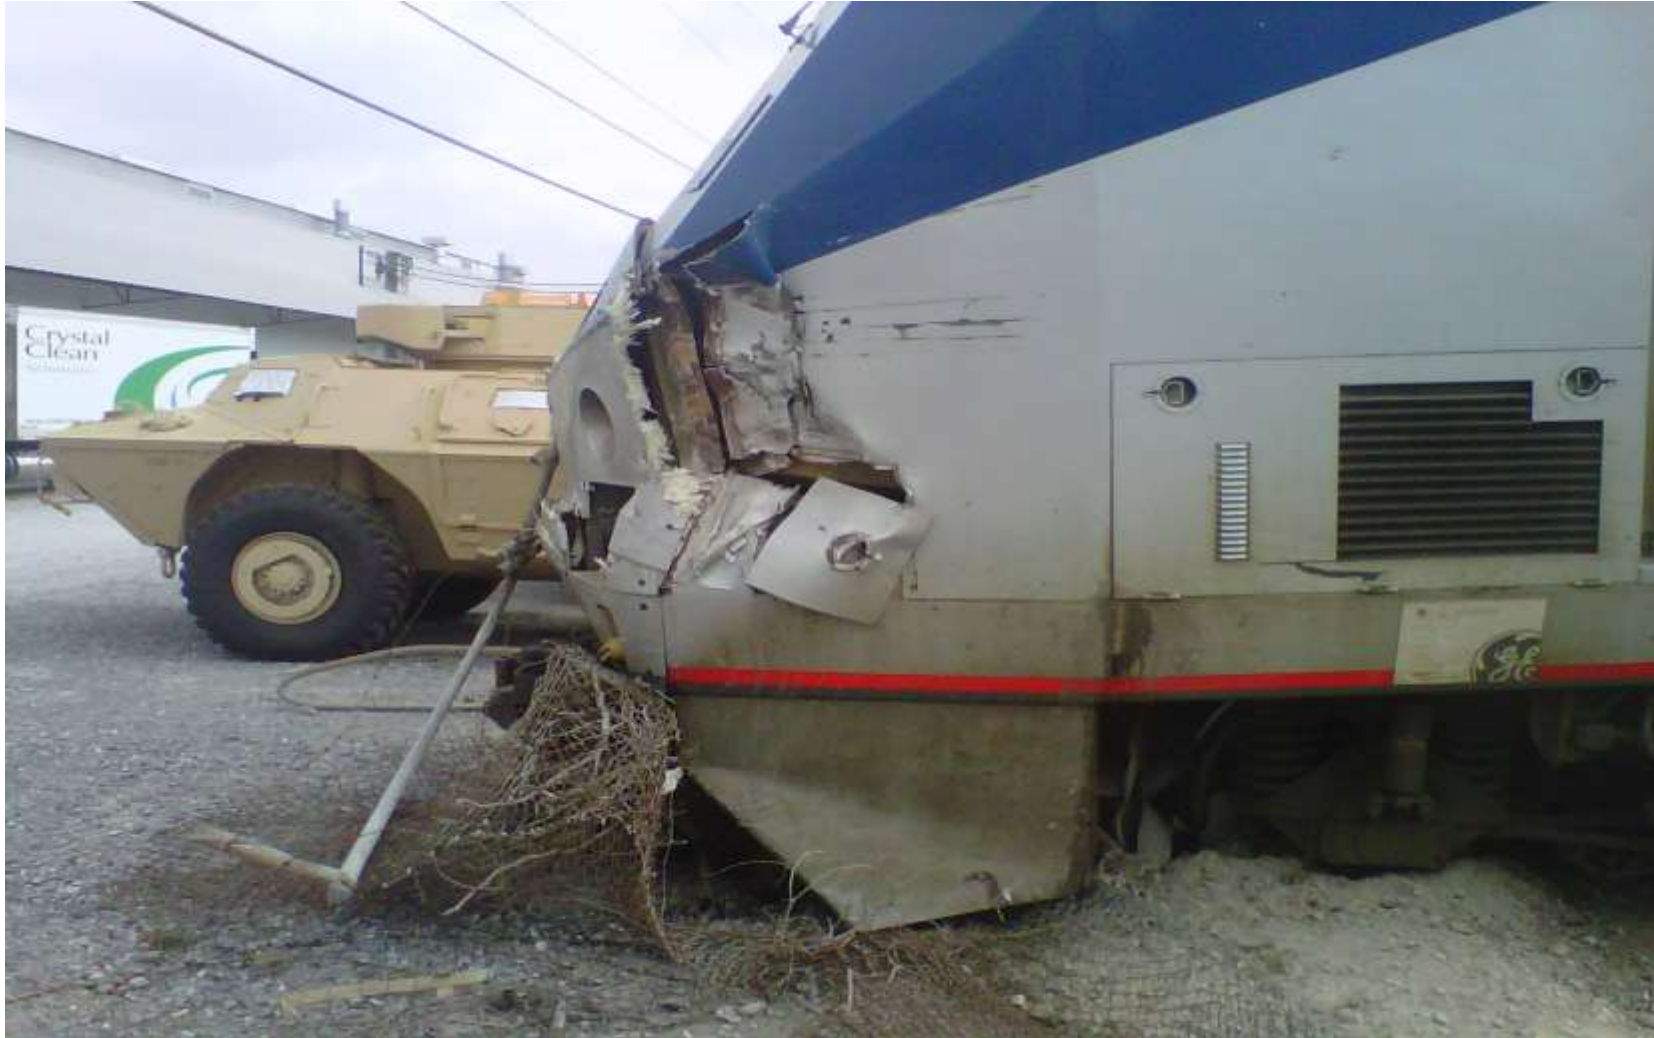
Impact damage to the lead locomotive
