Train Derailment – Slidell, LA.

Amtrak Passenger Train

April 20th, 2011

Train Derailment

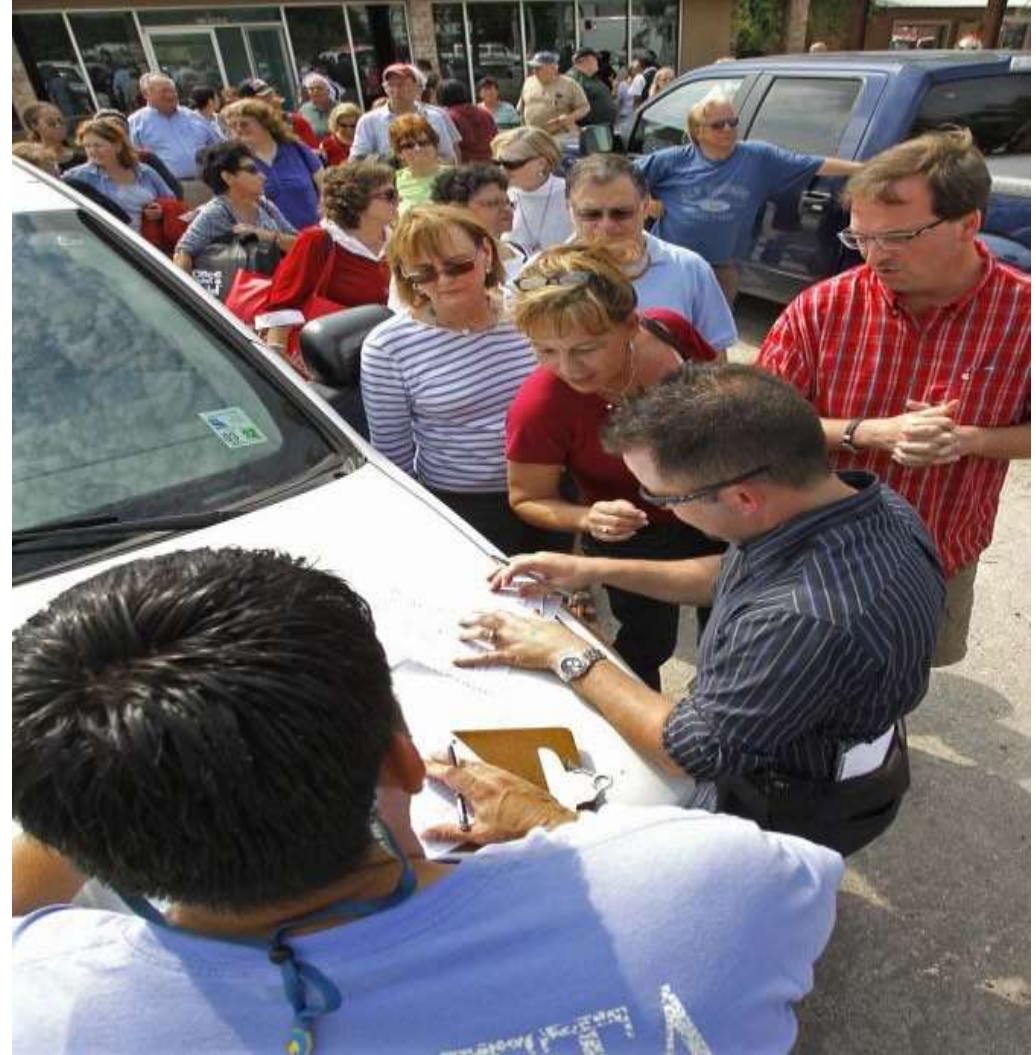
- The passengers were taken off of the train and moved across the street to a local café. AASI and fire crews assisted Amtrak personnel in the operation.
- Often during incidents like this many passengers will just leave the scene on their own. This causes serious problems with accountability.

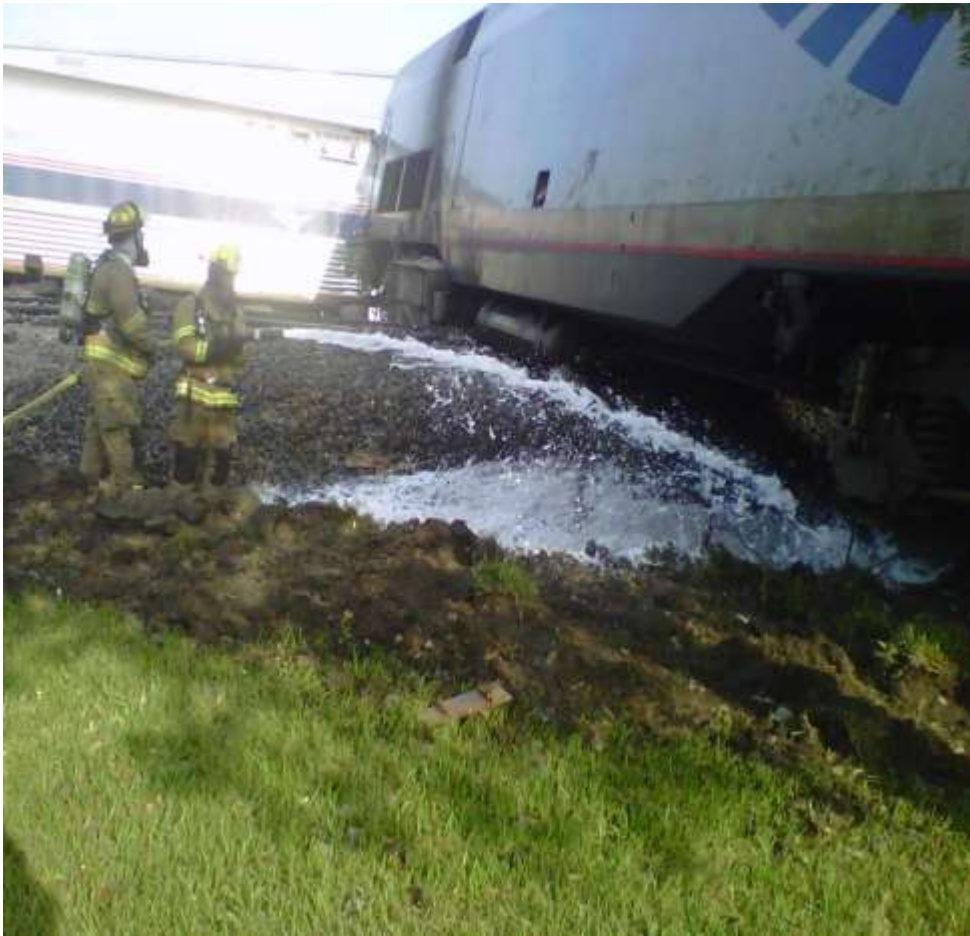
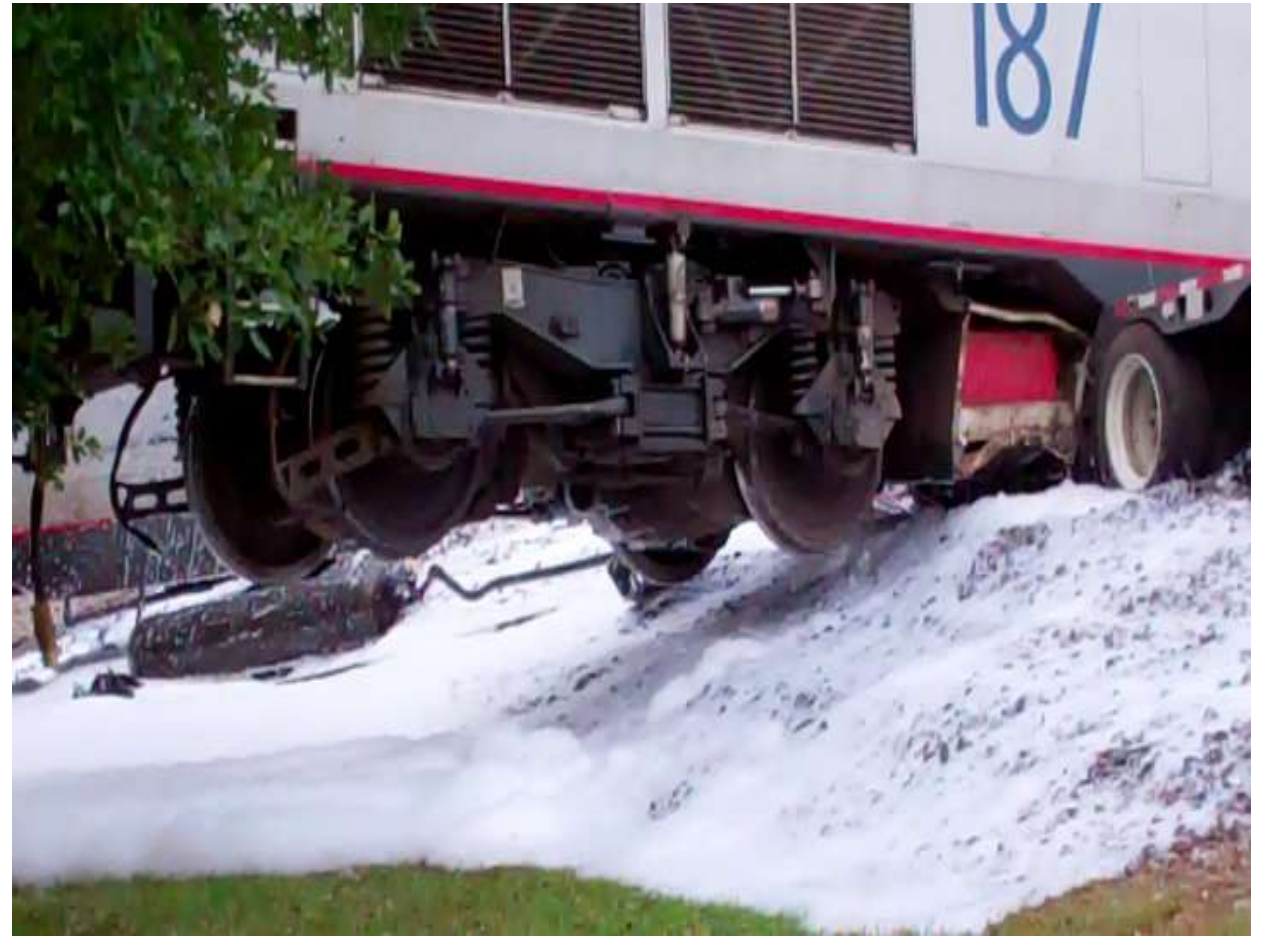
Foam Operations

- *E-13 and Acadian located and treated all passengers, driver, and engineer.*
- *L-11 extinguished fire and applied foam to area of spill*
- *City applied sand to area building a berm keeping fuel from spreading to drainage pipes.*

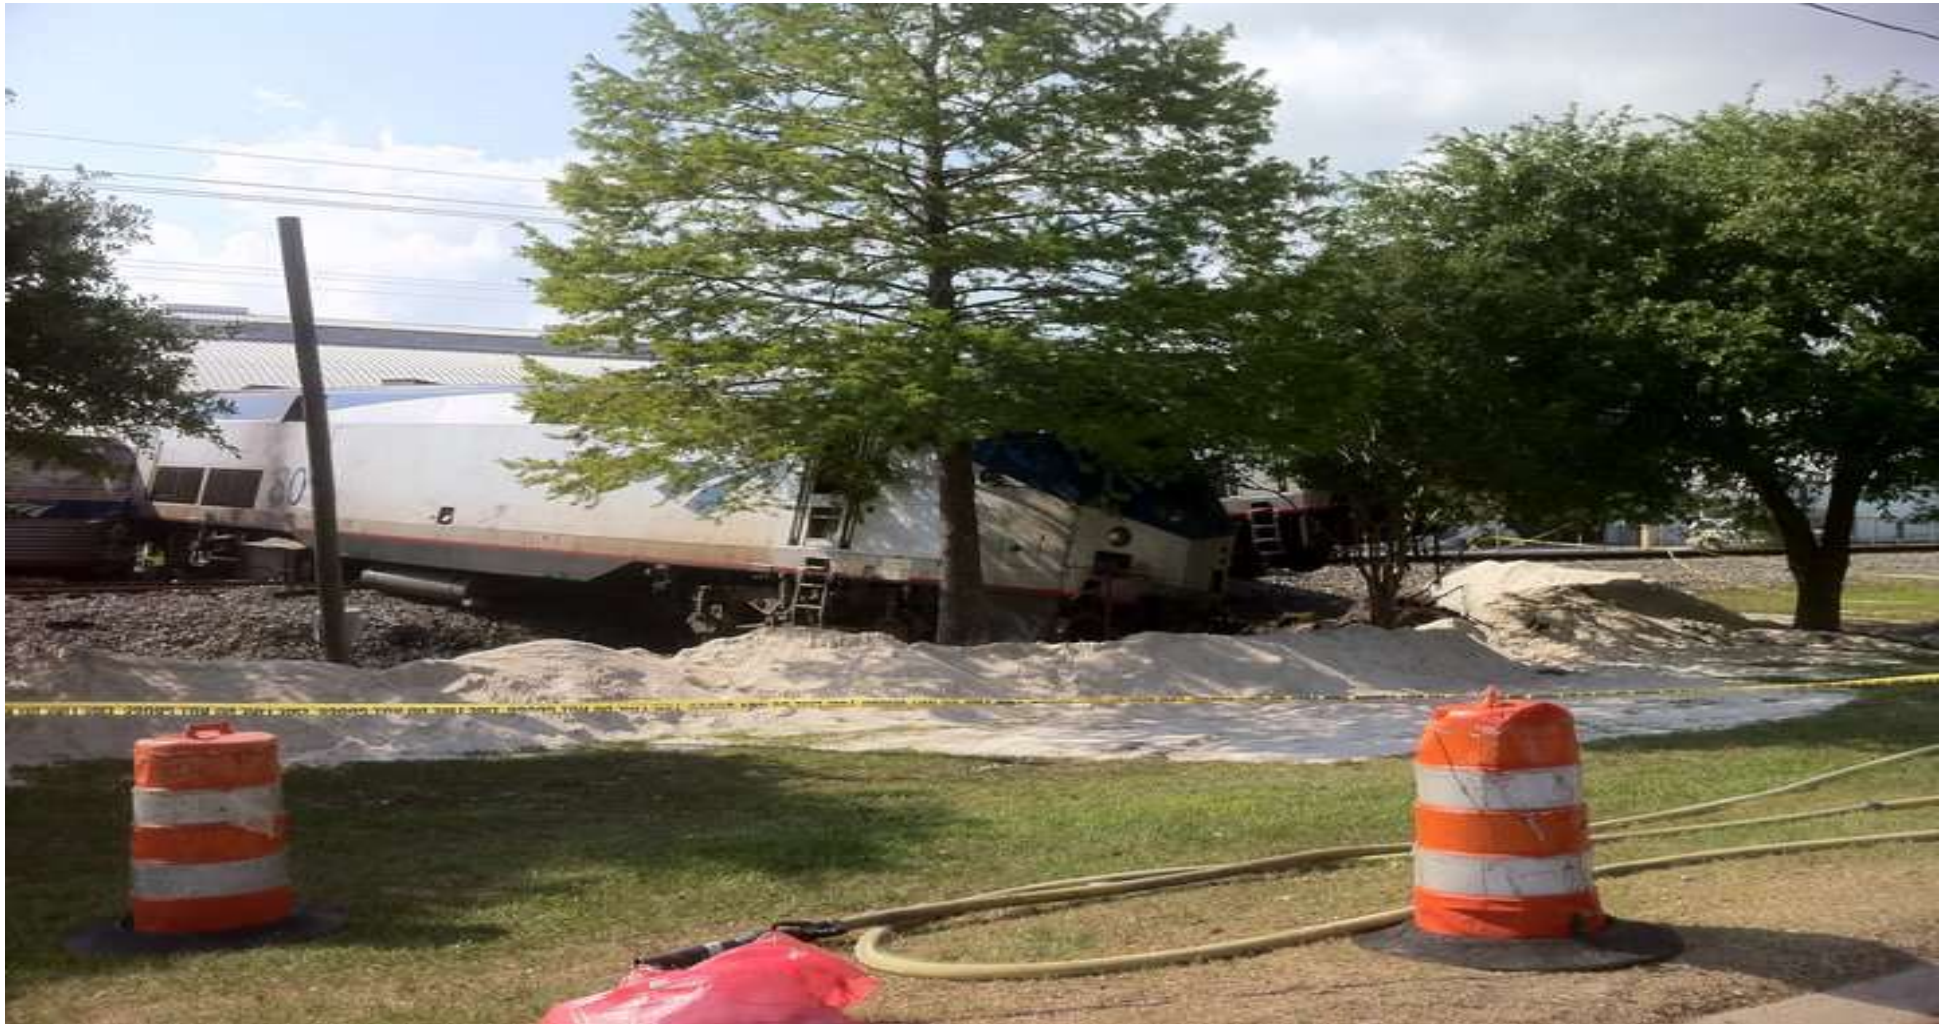
Diking Operations

- The City of Slidell Public Works Department did an excellent job in responding to the incident. Public Works sent 2 dump trucks and a front end loader loaded with sand.
- We meet with the supervisor and planned out the formation of the needed dike. The Public Works created a very good dike that contained the diesel fuel.

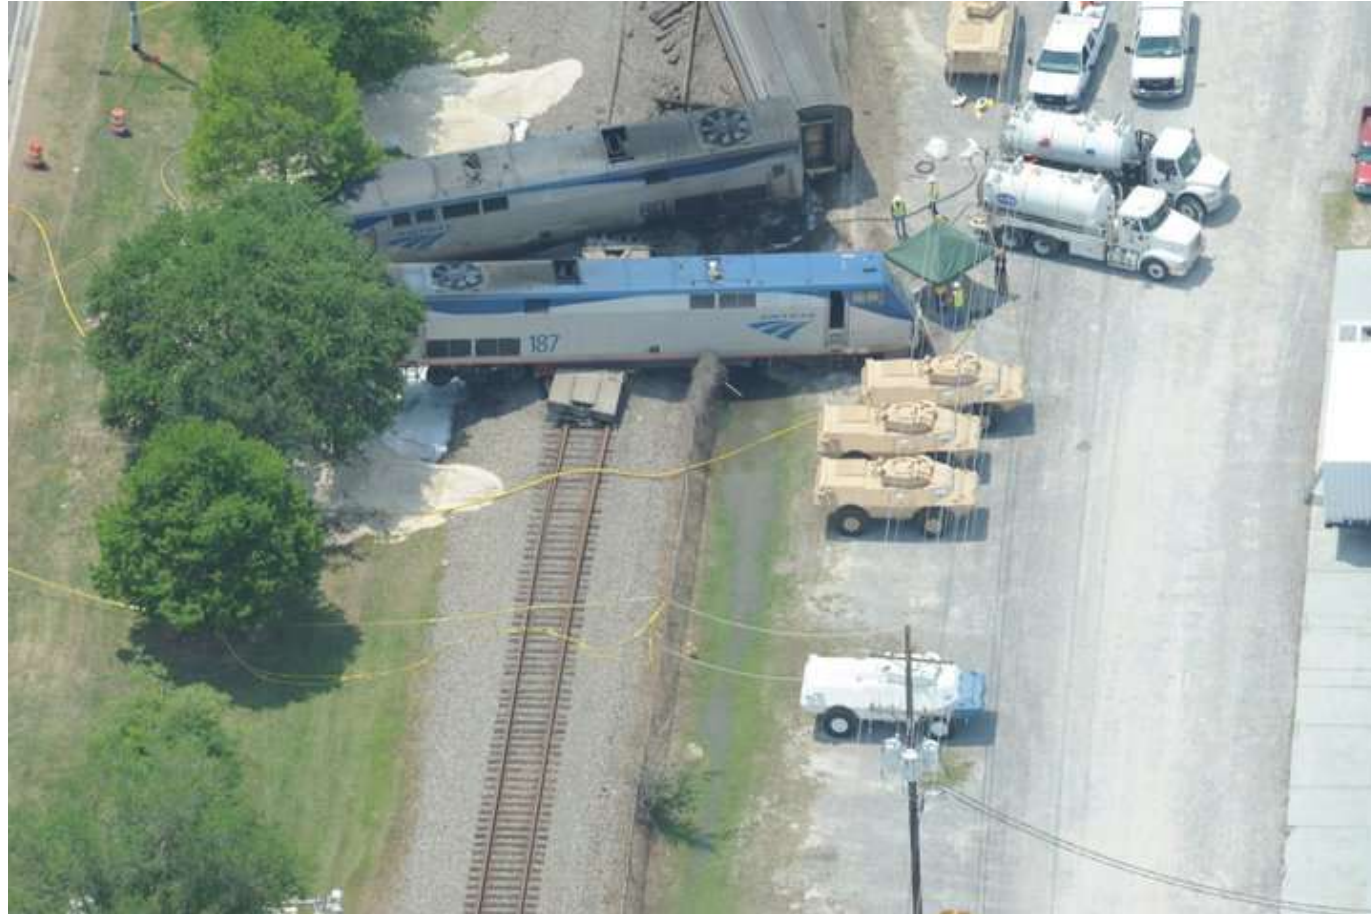
Off Loading the Fuel Tanks

- The contractor brought in 2 trucks to off load the diesel.
- Fire Department Hazmat Officer was assigned to the off loading operation and ensure it was done properly.
- Grounding and bonding was conducted before the operation was started.
